Swift Conservation www.swift-conservation.org

Roof Repairs & Re-Roofing with Swifts

Follow these simple guidelines to comply with the law and keep Swifts safe and breeding in your roof.

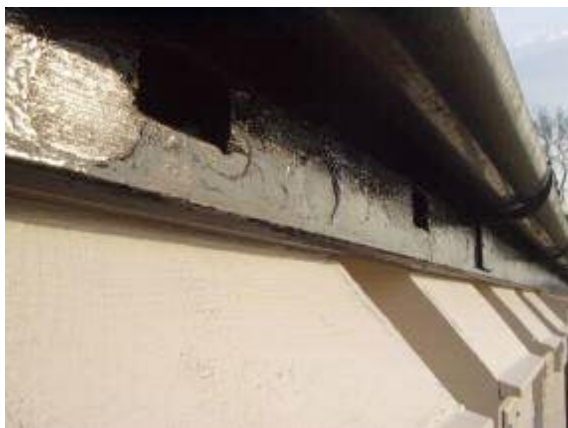
Holes cut in the facing boards let the Swifts reach their nests in the eaves of this chapel
Photo © Mark Glanville

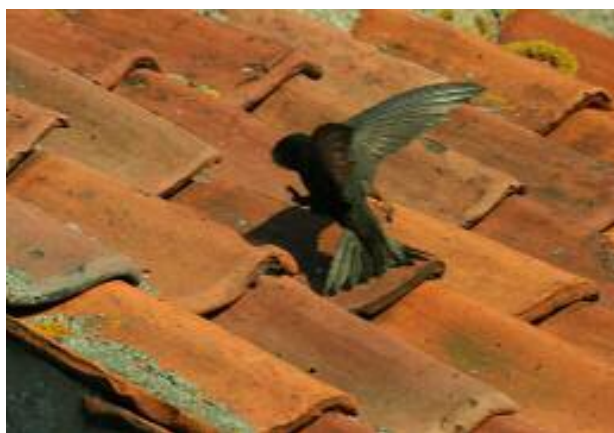
A Swift entering a roof via a displaced pantile. The nest is on the roofing felt below
Photo © Bill Ball

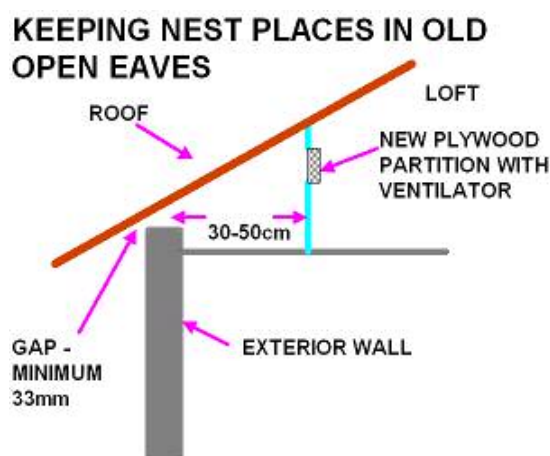
If you have to, install a ventilated plywood partition at least 30cm inside the loft to enclose the Swift nest areas and make the loft area usable, as shown below.

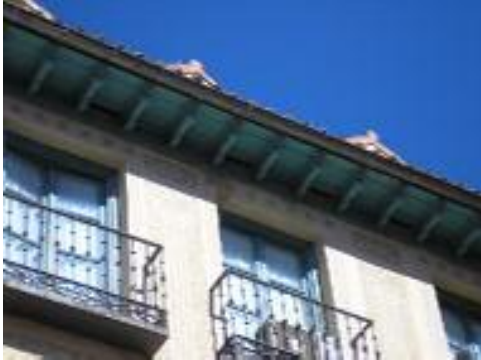
Swifts breed inside the eaves of this hotel at the Escorial, in Spain. Access slots (seen as dark lines at the top of the wall) are left free for them to enter and also to ventilate the roof space.

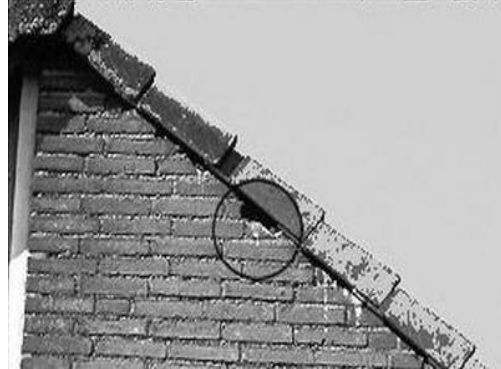
Swifts nest under the tiles on the brick ends of this roof. Repairs would evict them, but leaving the bricks as they are and fitting deeper tiles, offset to maintain the Swifts' access from below, will provide weather proofing and still let the Swifts nest.

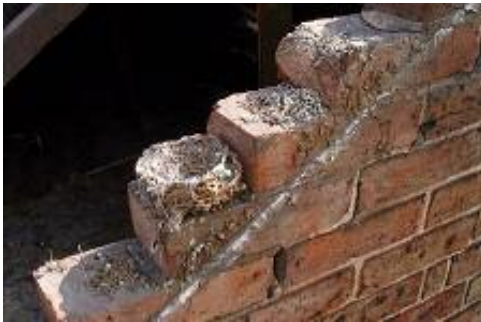
A Swift nest on a gable brick end, exposed when the barge boards were removed. Swifts can nest in very restricted places.

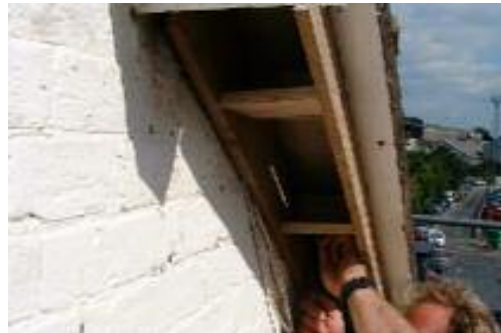
The gable brick ends shown exposed on the left have been fitted with bargeboards containing staircase type nest boxes. These will be faced with a plank with entrance holes cut for the Swifts to access the new nest places inside.

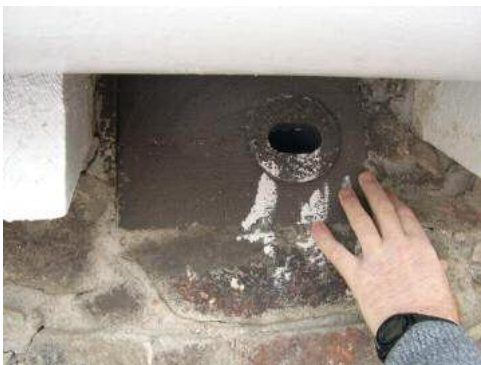
A Schwegler "Swift Brick" inserted into previously open eaves to provide a replacement Swift nesting place. The roof of this NHS hospital had to be sealed to meet hygiene requirements, but the Swifts' nests were saved.

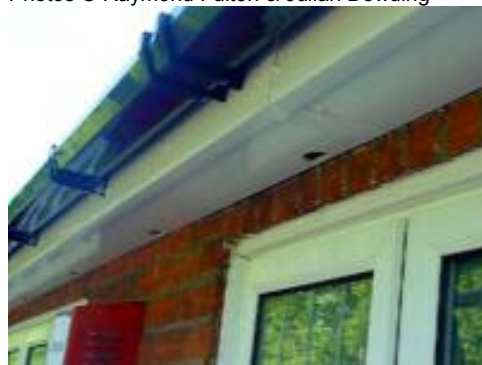
Plastic soffits and gutters have been fitted to this re-roofed house. Holes have been cut in the soffits close to the wall to provide access for the Swifts to their nests in the eaves.
