SWIFT CONSERVATION

Roof & Gable Repairs & Re-Roofing with Swifts

Follow these simple guidelines to comply with the law and keep Swifts safe and breeding in your roof

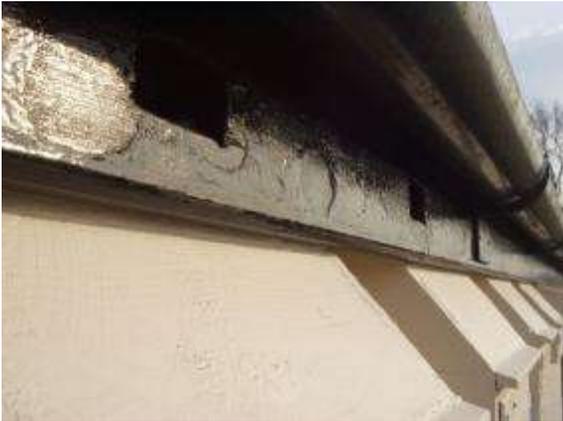
Holes cut in the facing boards let the Swifts reach their nests in the eaves of this chapel
Photo © Mark Glanville

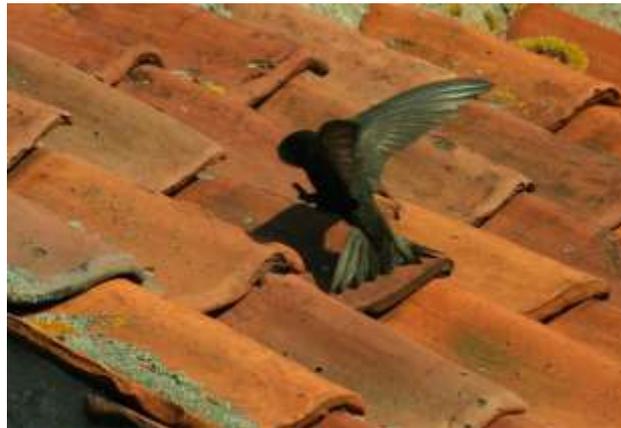
A Swift entering a roof via a displaced pan tile. The nest is on the roofing felt below
Photo © Bill Ball

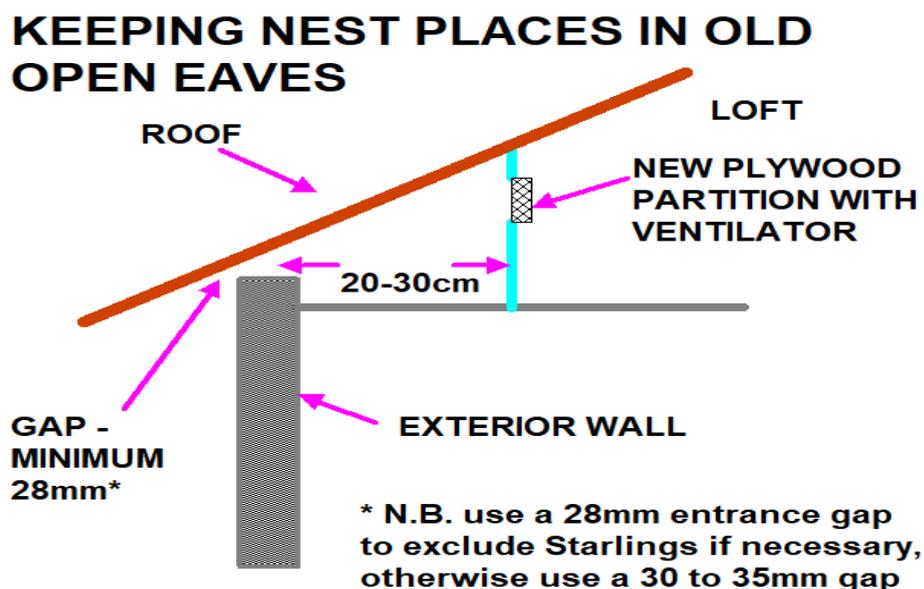
If you have to, install a ventilated plywood partition at least 30cm inside the loft to enclose the Swift nest areas and make the loft area usable, as shown below. *More drawings and details are shown on the last page*

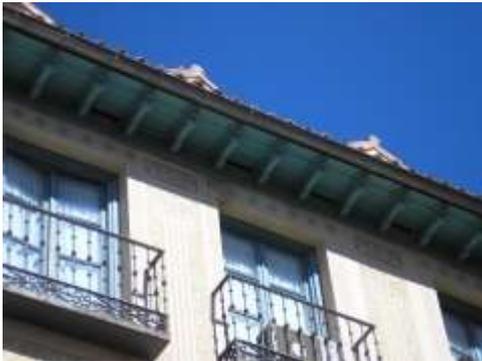
Swifts breed inside the eaves of this hotel at the Escorial, in Spain. Access slots (seen as dark lines at the top of the wall) are left free for them to enter and also to ventilate the roof space.

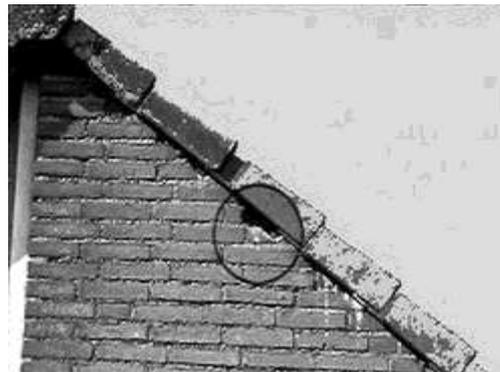
Swifts nest under the tiles on the brick ends of this roof. Repairs would evict them, but leaving the bricks as they are and fitting deeper tiles, offset to maintain the Swifts' access from below, will provide weather proofing and still let the Swifts nest

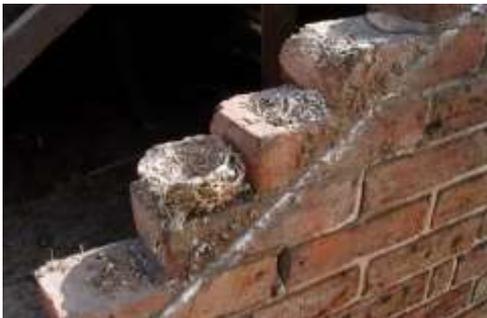
A Swift nest on a gable brick end, exposed when the barge boards were removed. Swifts can nest in very restricted places

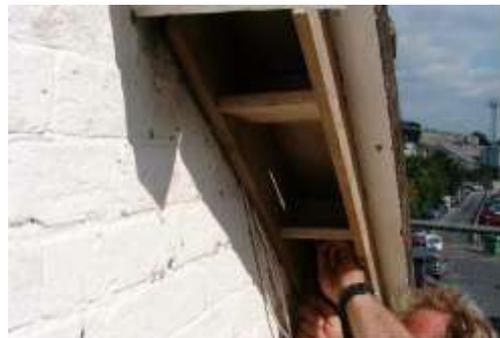
The gable brick ends shown exposed on the left have been fitted with bargeboards containing staircase type nest holes. These will be faced with a plank with entrance holes cut for the Swifts to access the new nest places inside

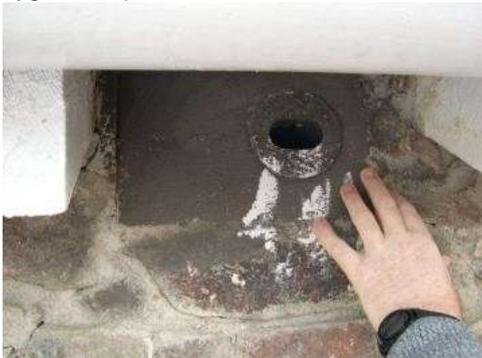
A Schwegler "Swift Brick" inserted into previously open eaves to provide a replacement Swift nesting place. The roof of this NHS hospital had to be sealed to meet hygiene requirements, but the Swifts' nests were saved

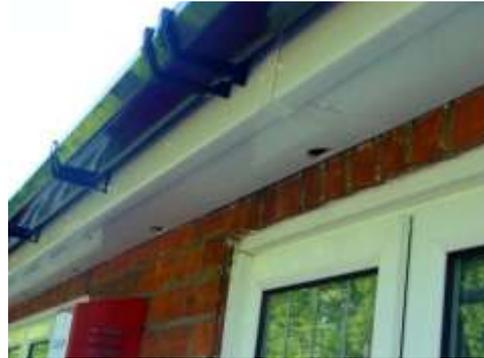
Plastic soffits and gutters have been fitted to this re-roofed house. Holes have been cut in the soffits close to the wall to provide access for the Swifts to their nests in the eaves

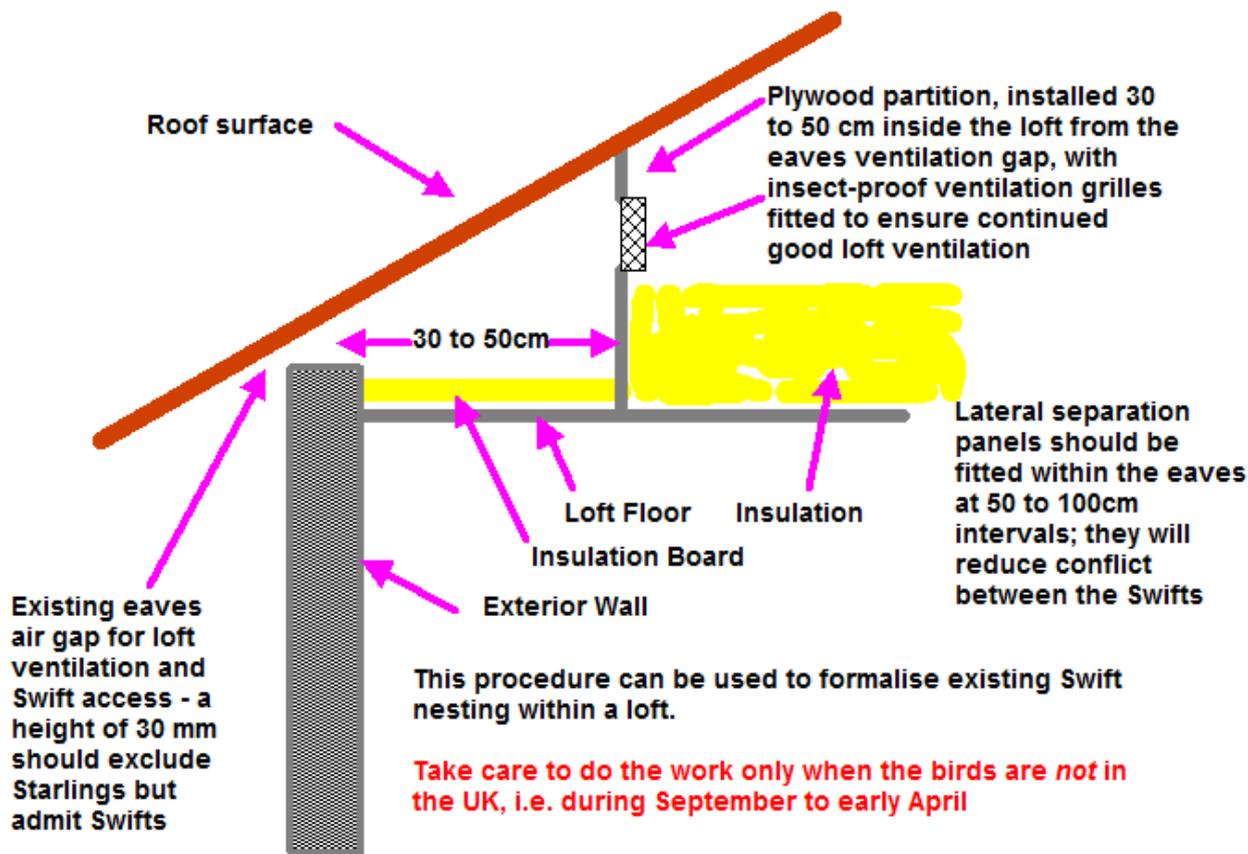
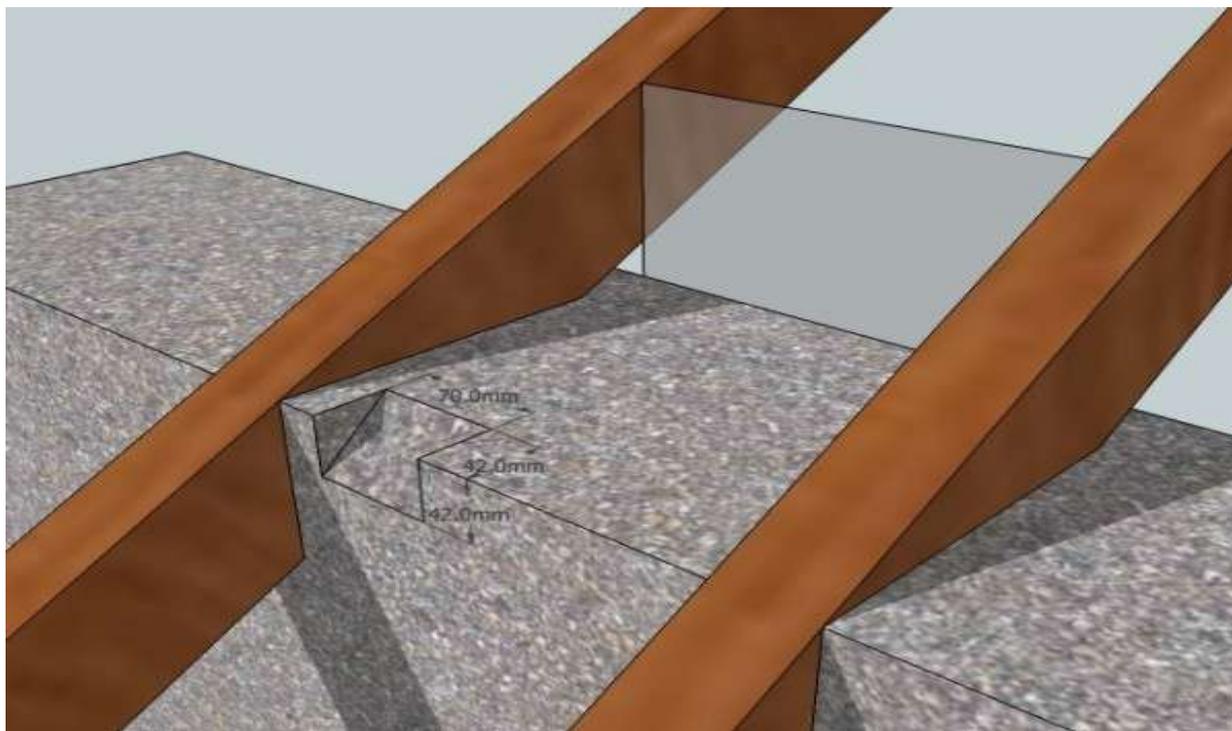
Above: examples of how to maintain Swift nest places in “open” eaves when these have to be rebuilt or re-roofed. For more advice and help on this and other ways of helping Swifts survive please contact Swift Conservation
