# Roof Repairs & Re-Roofing with Swifts

Follow these simple guidelines to comply with the law and keep Swifts safe and breeding in your roof.

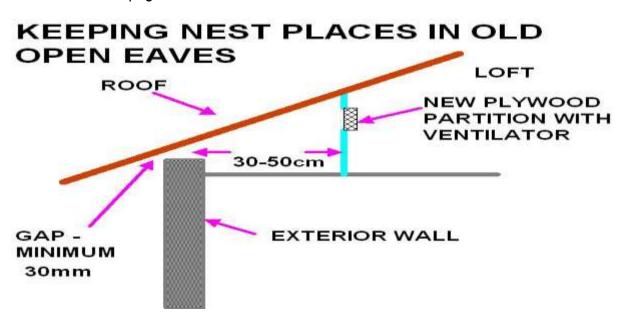
If you have to, install a ventilated plywood partition at least 30cm inside the loft to enclose the Swift nest areas and make the loft area usable, as shown below. *More drawings and details are shown on the last page.*

**Eaves nests- leaving the eaves open** is the simplest & best solution or cut slots in the soffit or facing boards to match the old entrances

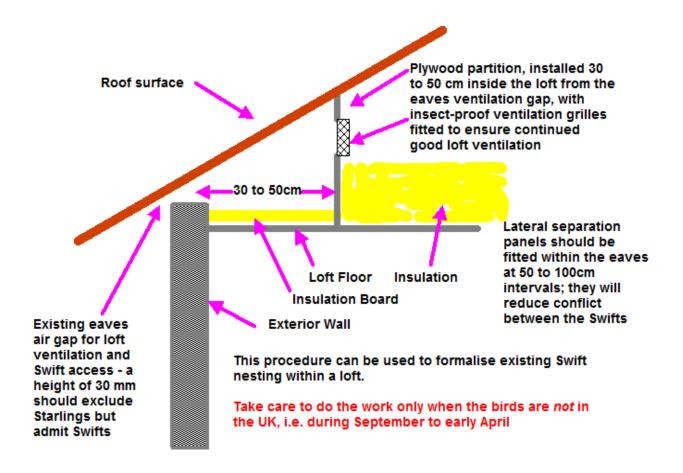
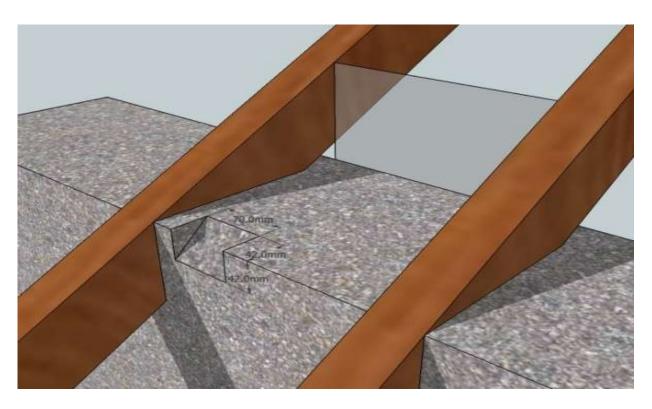
Above: examples of how to maintain Swift nest places in "open" eaves when these have to be rebuilt or re-roofed. For more advice and help on this and other ways of helping Swifts survive in the modern world please contact Swift Conservation
